CACHING, UNDERWATER 177A  
STORAGE CONTAINER

I RESULTS OF INSPECTION OF SEA-WATER-IMMERSED  
AND UNDERGROUND-BURIED CONTAINERS AND  
SPECIMENS - CONDUCTED MAY 27-30, 1958

Final Report  
CONFIDENTIAL

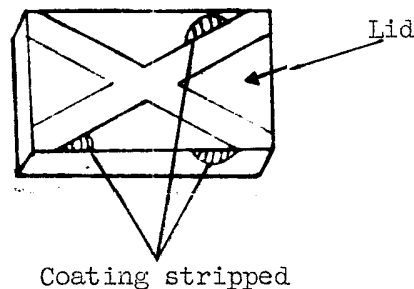
Container No. 7 (With Vinyl Coating)

Numerous blisters,  $1/8$  to  $1/2$ " in diameter, were noted throughout; they were partially water filled. The coating adhesion was very poor. The coating could be stripped from the metal with little difficulty; the coating was peeled at three places during the examination, as shown:
